Lenovo Tab 2 A8 Front-Facing Camera Replacement

Front-facing camera isn't working? This guide will show you how to switch it out with a new one.

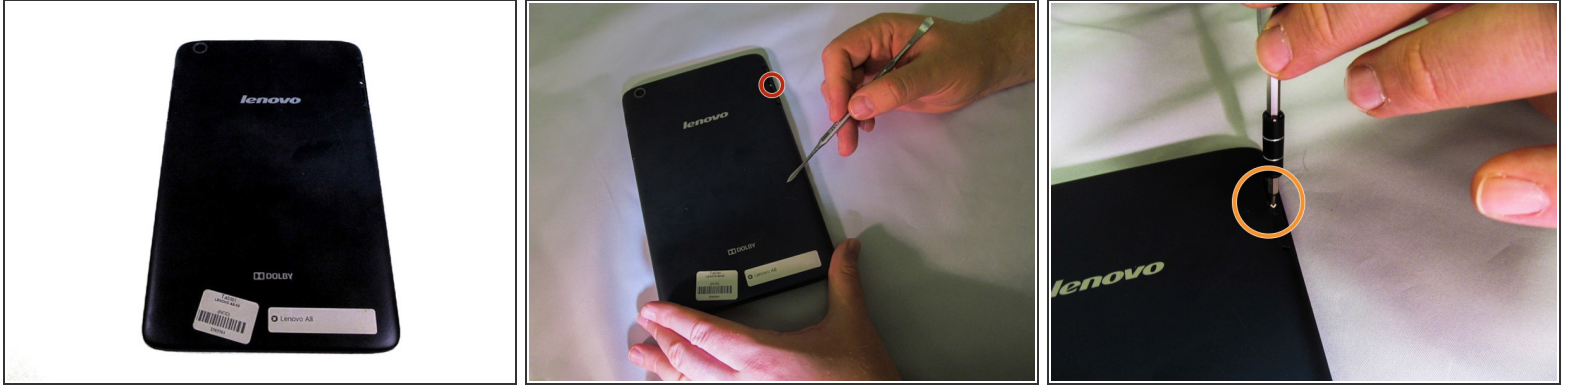
Step 1 — Removing the Back Panel

- Place the tablet face down on a soft, stable surface that will protect the screen.
- Next, Scrape off the seal over the screw in the back of the tablet with a Metal Spudger.
- Use the Phillips #000 Screwdriver to remove the M1.4 × 2.5 screw.
 - ⓘ If the seal covering the screw has already been removed, please proceed to the next step in the process.
 - ⓘ As the screw is small, you may wish to extract it using a pair of tweezers.

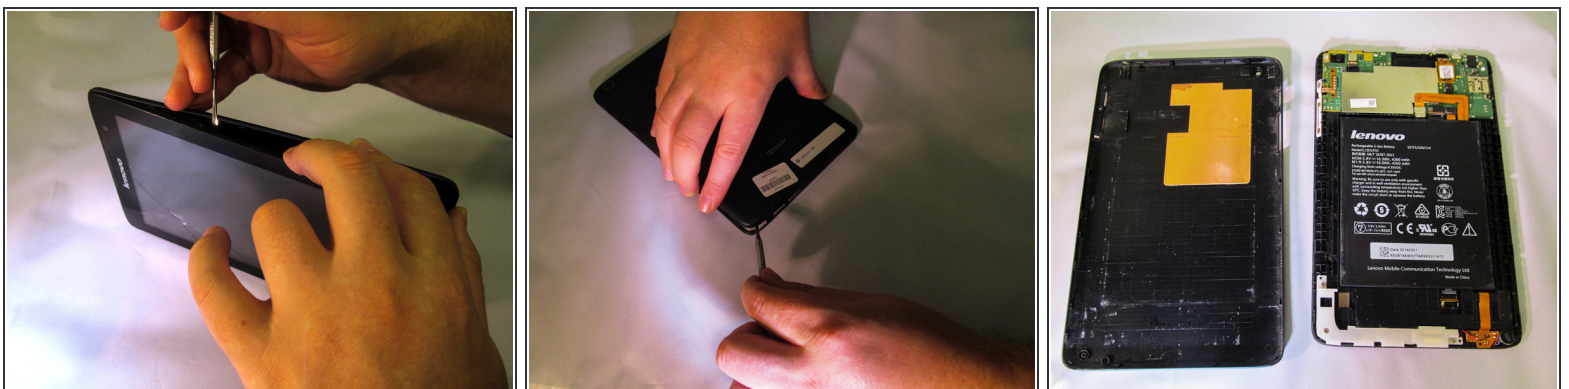
Step 2

- Starting on the side, work your way around the the tablet to pop off the back cover. You will want to utilize a metal Spudger for this.
 - ⓘ Some force may be required initially to pry the back cover off.
 - ⓘ Note that the button tabs for this device are loose inside the case and will fall out when opening.

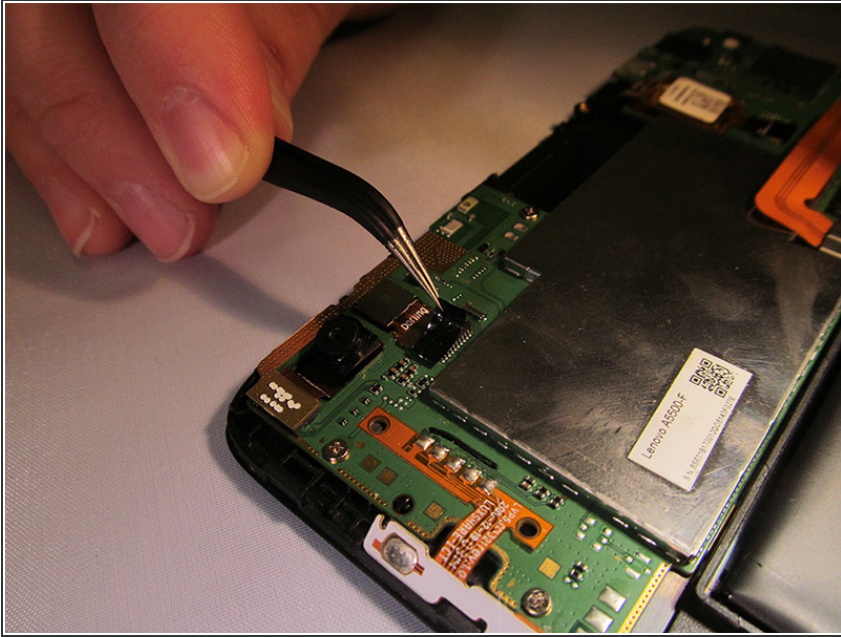
Step 3 — Front-Facing Camera

- Using tweezers, peel off the anti-static sticker from the camera connection port.

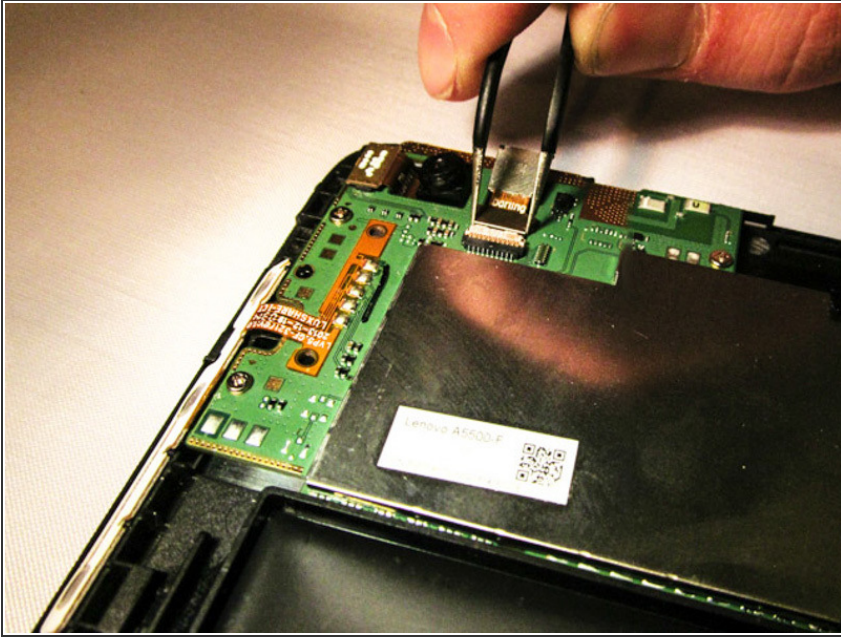
Step 4

- Lift the camera out of its socket in the motherboard. Then, using tweezers to grasp the camera connector, carefully pull the connector horizontally out of the port.

i Be aware that the camera connector will be firmly lodged in the port. When successfully removed, the top side of the port pops up.

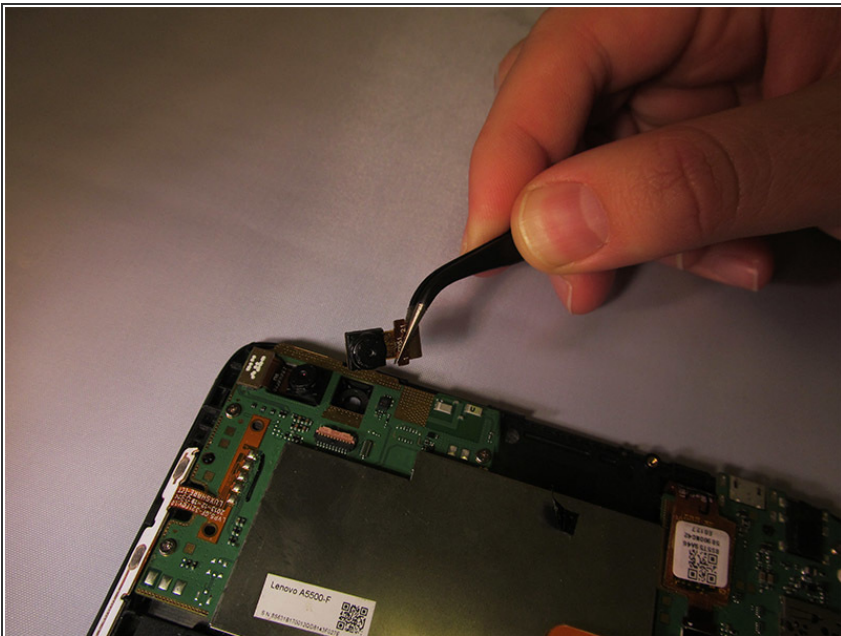
Step 5

- Using tweezers to grasp the camera connector, lift the camera out of its socket.

To reassemble your device, follow these instructions in reverse order.
